REST-COAST

LARGE SCALE RESTORATION OF COASTAL ECOSYSTEMS
THROUGH RIVERS TO SEA CONNECTIVITY

EBRO DELTA

RESULTS & ACHIEVEMENTS REPORT

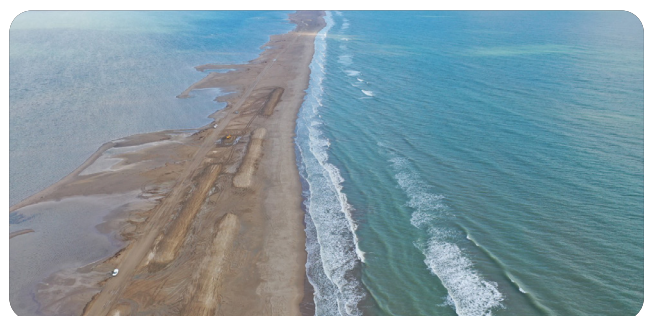
Trabucador dunes – pre storm sequence in December 2022

This dual approach addressed both the inland lagoon and the exposed coastal frontage simultaneously. At the Trabucador bar, an alternating alongshore dune system was built along the full 6

km length of the barrier beach, designed to allow controlled overwash and create a sediment stock that can be mobilised during storms. At Marquesa beach (1.6 km), 62 perpendicular dunes were constructed to fix sediment in the valleys and increase roughness, with a green core dune incorporating seagrass debris to increase structural strength.
